# RISK ALERT

## Pumproom Fatality

The Club would like to draw Members' attention to the recently issued [Transport Malta Safety Investigation Report No 03/2021](#) concerning a fatality in the pumproom of a crude oil tanker.

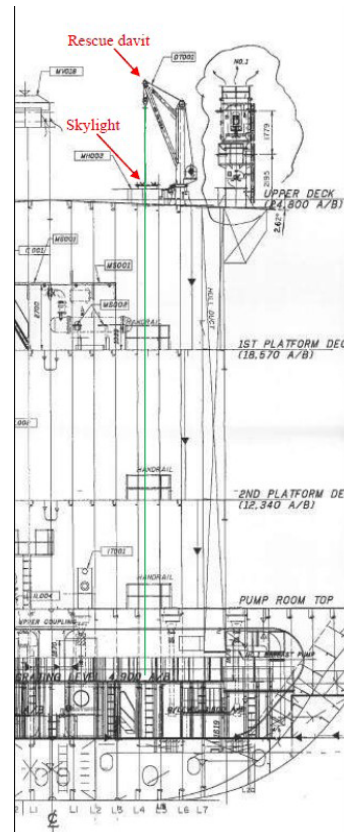
The location of the starboard bilge alarm, and the proximity of the pumpman to the alarm, meant that when he collapsed the pumpman was not readily visible to the rescue party. The awkward and confined location of the bilge also meant that, when strapped into the rescue stretcher it was not possible to lift him to the level of the gratings, from where the rescue davit could be utilised to recover him from the pumproom. It was ultimately necessary to remove the pumpman from the stretcher and manually lift him to the gratings to effect recovery.

[Ref TM Report 03/2021](#) - Rescue davit (green line indicates direction through which its wire passes) - © Copyright TM, 2021

**Enclosed and restricted space recovery procedures**, as was experienced in this instance, access to some locations on a vessel, particularly in areas such as pumprooms and bilge spaces, may be restricted due to the layout and structure of the vessel. Emergency exercise and drills should be utilised to identify potential problem areas and risk assessments and contingency measures should be identified, implemented and exercised against. Whilst not highlighted in the investigation report, the availability of an Emergency Escape Breathing Device (EEBD) may have been beneficial. Had the pumpman detected gas and donned an EEBD he may have been able to leave the bilge spaces in a controlled fashion. The provision and carriage of EEBD's being one of the corrective actions implemented post incident.

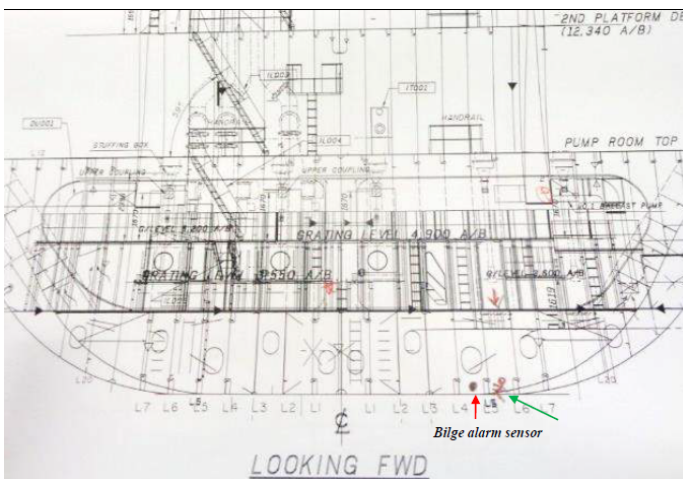
Post accident atmosphere checks of the bilge area where the pumpman was found returned H<sub>2</sub>S readings of between 2 and 20ppm (these checks were conducted some 24 hours post incident and after the vessel had berthed). The Threshold Limit Value (TLV) of H<sub>2</sub>S is stated to be 5ppm as Short Term Exposure Limit (STEL) and both *n*-Butane and H<sub>2</sub>S are known to be naturally found in crude oil. The investigation could not exclude the possibility that the pumpman was overcome by H<sub>2</sub>S and was then left exposed to high concentrations of *n*-Butane. (*n*-Butane and H<sub>2</sub>S are both heavier than air).

The autopsy identified that the pumpman **struck his head** and it is possible that this happened as the pumpman was trying to exit the bilge space. Whilst not proven, there is a theory that the pumpman may have sensed the presence of **H<sub>2</sub>S** and, that as a consequence, he may have been trying to make his way out of the bilge space. There was also a small quantity of **oily water** in the starboard bilge space and it is thought that this may have caused the pumpman to slip and strike his head, rendering him unconscious and further exposing him to the toxic gases.

[Ref TM Report 03/2021](#) - Location where the fatally injured pump man was found (green arrow) - © Copyright TM, 2021

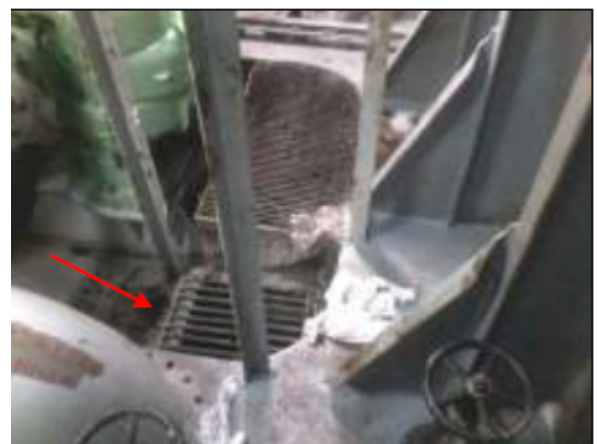
Location of the **bilge alarms and access** for testing. Whilst the port bilge alarm was quite readily accessible, access to the starboard bilge alarm required entering a restrictive and confined area of the bilges, where it is possible that concentrations of gases may have built up that were not detected by the fixed gas detection system.

The **gas detection** alarms were not activated around the time of the incident, and the nearest gas sampling suction point was 4.5m from the access manhole to the starboard bilge alarm sensor. It is reported that the location of the sampling point would have compromised the effectiveness of the gas detection system in detecting the presence of gas near the sensor. The system was last maintained by a shore service provider approximately 4 months prior to the incident. At the time of the service, it was observed that hydrocarbon samples collected from the portside of the pumproom bottom, and above the lowest grating, could not be set to match the contents of the calibration gas. The same was noted for H<sub>2</sub>S samples extracted from the pumproom bottom on the stb'd side.

[Ref TM Report 03/2021](#) - Access manhole for stb'd side bilge sensor (Red arrow) - © Copyright TM, 2021

**Gas detection** systems, fixed and personal. Verify and test the effectiveness of such systems and where any anomalies are identified, as was identified by the shore service provider in September 2019, investigate and

rectify the anomaly. There should be clear guidance on the use and inter-relationship between the use of fixed, personal and portable gas detection systems.

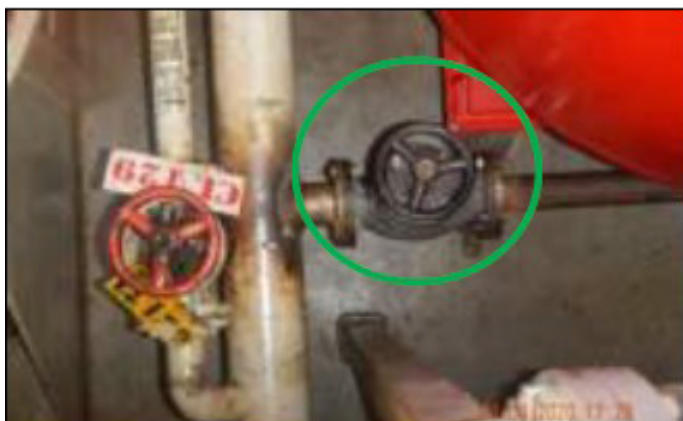
**Maintenance and house keeping:-** The small leak in the suction valve of the pump-room's starboard bilge, combined with the routine draining of water during the warming up of the stripping pump, could potentially have contributed to this incident and highlights the necessity to address and rectify deficiencies and to always maintain appropriate standards of cleanliness and housekeeping. Robust maintenance regimes and good housekeeping should be implemented to prevent slips, trips and falls

[Ref TM Report 03/2021](#) - Suction valve (circled in green) of the starboard bilge of the pump room - © Copyright TM, 2021
