## Use of Plastic Sheathing on Freefall Lifeboat Recovery Strops

This Risk Alert has been written by Taslim Imad, of the Loss Prevention Team

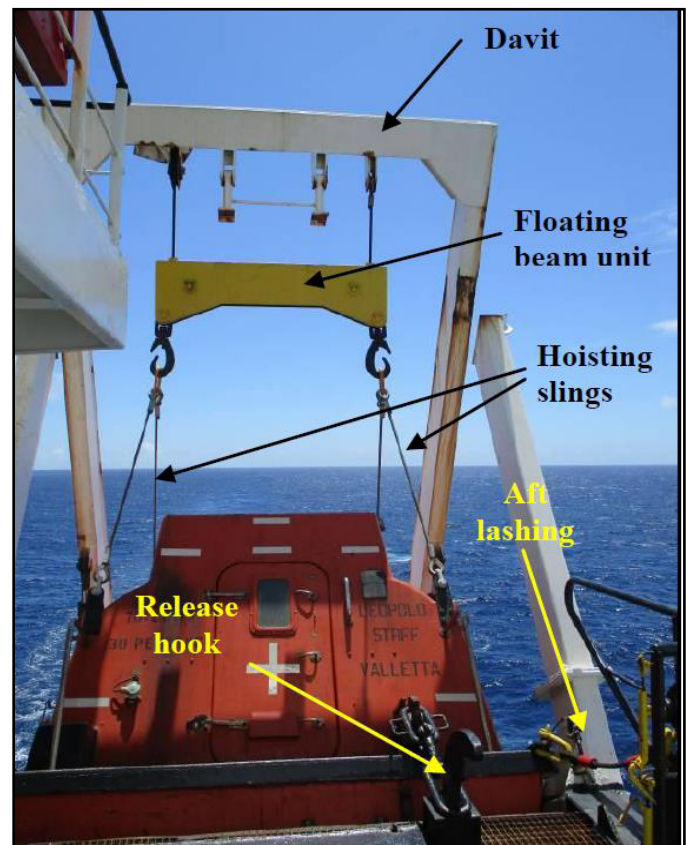
Extracted from the Marine Safety Investigation Unit of Transport Malta investigation report of *MV Leopold Staff*

Prior to undertaking the maintenance, the Chief Officer completed a dangerous work permit which included a risk assessment, approved by the Master. After completing a visual check of the FFLB lashing arrangements (Aft lashing) and hoisting wires, and finding them to be in good condition, the hoisting slings were attached to the davit's floating beam/ hooks to safely secure the lifeboat. Once the lifeboat was secured the Bosun was instructed to lift the lifeboat a few centimetres off the ramp after which the Third Officer boarded the lifeboat and activated the freefall releasing mechanism to test the release of the release hook. After successful activation of the release hook the Third Officer disembarked the lifeboat and disconnected the aft lashings and the power cable.

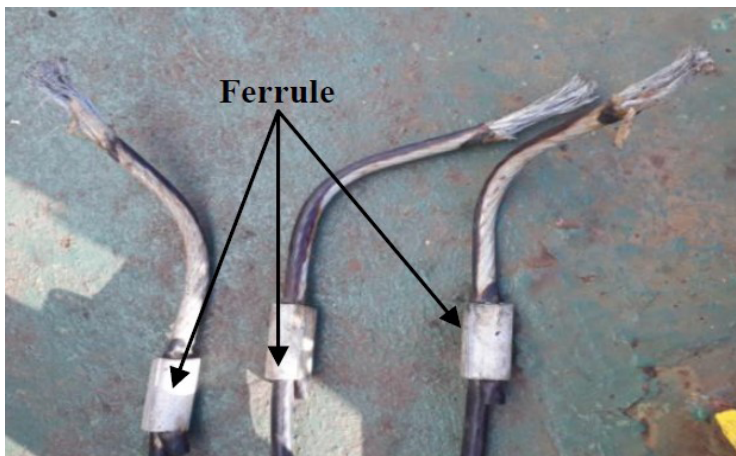
Extracted from the Marine Safety Investigation Unit of Transport Malta investigation report of *MV Leopold Staff*

At this point the full weight of the FFLB was being held on the hoisting slings. The Chief Officer then instructed the Bosun to lower the FFLB back onto the ramp and slide it down the ramp to facilitate routine maintenance works on the rollers of the lifeboat davit's ramp. As soon as the lifeboat had been lowered a few metres it was observed that the wires of hoisting slings were slipping through their ferrules one by one, and consequently the lifeboat slid down the ramp and went overboard.

Evidence gathered by the MSIU suggested that the steel wires making up the hoisting sling had slipped through their ferrules because the steel wires passing through the ferrules were not fused together. The MSIU believes that the wires failing to fuse together could have occurred due to –

- Inadequate pressure being applied during the swaging and / or
- The presence of sheathing inside the ferrule

In the meantime, it is recommended that Members check the condition of all wires associated with LSA equipment, and replace immediately with equivalent type approved wires, where the wires are found to be or suspected of being corroded or deteriorated to the extent that their strength is or may be compromised.

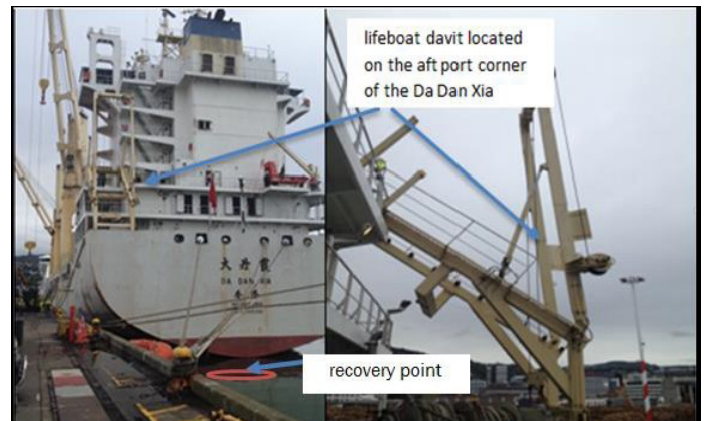
Extracted from the Transport Accident Investigation Commission of New Zealand accident report of *M.V. Da Dan Xia*

The FFLB was lowered into water with no crew on board and once lowered in the water, four crew members boarded the lifeboat and manoeuvred it in the harbour. After the manoeuvring tests, the crew connected the lifeboat to the retrieval davit for recovery to the ship. During the recovery operation, at approximately deck level, and with the four crew members in the lifeboat, first one, and then the remaining hoisting sling wires parted and the lifeboat fell several metres into the sea.

The hoisting sling wires in this incident were encased in non-transparent plastic sheathing, which in this instance is believed to have facilitated and obscured the onset of corrosion of the wires.

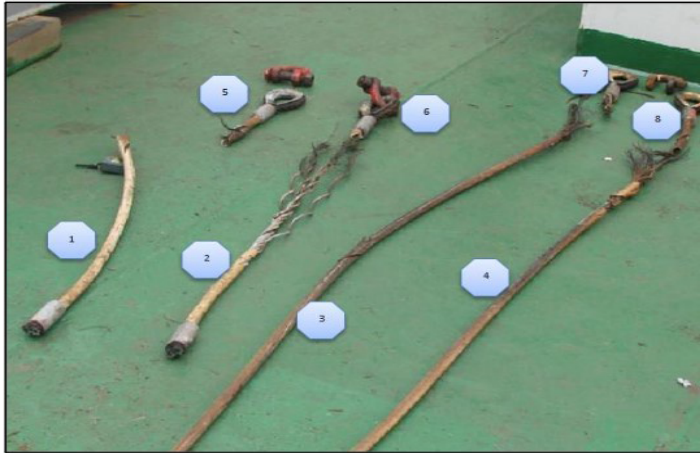
Extracted from the Transport Accident Investigation Commission of New Zealand accident report of *M.V. Da Dan Xia*

During the ship's working life, ingress of rain and seawater through the plastic sheathing can cause severe corrosion to the core of hoisting sling wires and prevent crew members from physically inspecting the condition of wires inside plastic sheathing.

At the same time it can also provide a false sense of security to the crew that wires within plastic sheathing would not become corroded.

It is important to remember that the presence of plastic sheathing encasing a wire rope means that it is not physically possible to inspect and maintain that wire rope as is required by SOLAS.

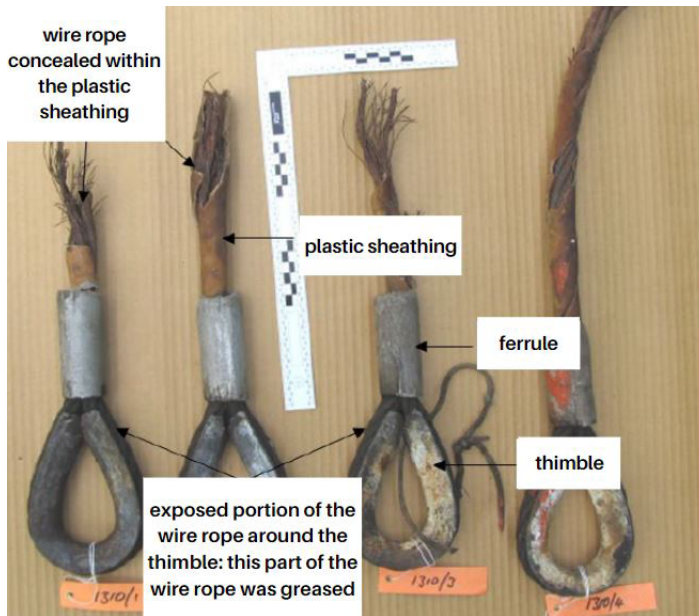
Extracted from the Transport Accident Investigation Commission of New Zealand accident report of *M.V. Da Dan Xia*

Both the MSIU of Transport Malta and TAIC of New Zealand concluded that plastic sheathing around hoisting wire slings contributed to these incidents.
